## WALL FACED SUITE INSTALLATION INSTRUCTIONS

PN600 ELLISSE  
 PN700 SLIM  
 PN730 L'HOTEL  
 PN760 LINFA  
 PN800 ELLISSE ACCESSIBLE  
 PN820 ELLISSE AMBULANT  
 PN900 ENVY III

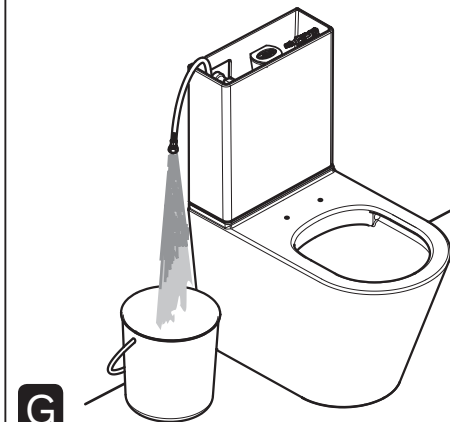
G

Connect Mini Stop Cock to braided stainless steel flexi-hose and **flush line into a bucket until water runs clean.**

Connect flexi-hose to inlet valve and open Mini Stop Cock allowing cistern to fill.

**DO NOT submerge flexi-hose.**
